# Access Compliance Report Public Rights-of-Way (Curb Ramps)

Main Street: NEWBURY\_RD Cross Street: INVERNESS\_DR Location: NE

ADA ID: RPRK211216134816 Ramp Type: Type 1 - Perpendicular Diagonal Initial Pass/Fail: Pass Overall Compliance: No Severity Score: 6

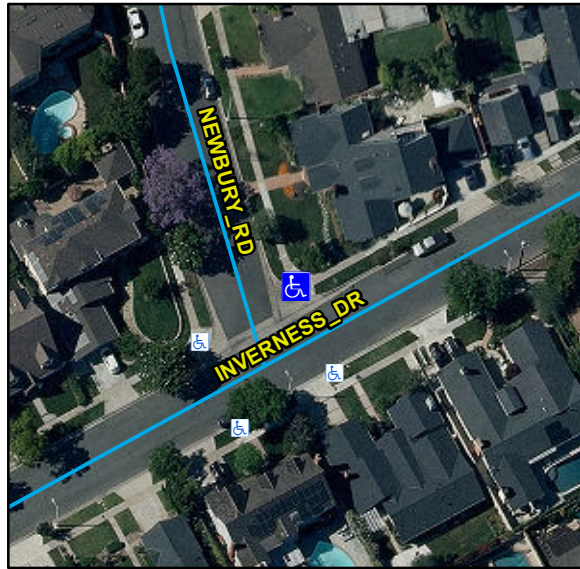
| Compliance | Description | Data | Compliance | Description | Data |
|---|---|---|---|---|---|
| No | Landing Run Slope (%) | 2.5 | N/A | Flare Traversable RT | No |

Remove & Replace Landing.
