# Access Compliance Report Public Rights-of-Way (Curb Ramps)

Main Street: HARRISBURG\_RD Cross Street: LORING\_DR Location: NE

ADA ID: RPRK211216135527 Ramp Type: Type 1 - Perpendicular Diagonal Initial Pass/Fail: Fail Overall Compliance: No Severity Score: 16

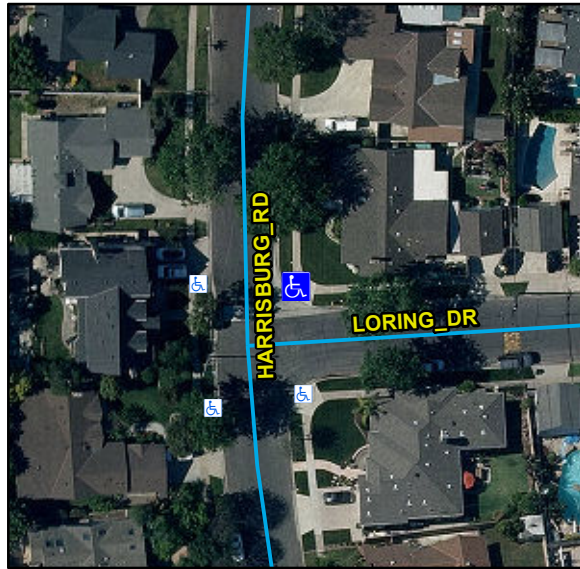
| Compliance | Description | Data | Compliance | Description | Data |
|---|---|---|---|---|---|
| No | Ramp Run Slope (%) | 8.7 | N/A | Flare Slope LT (%) | N/A |

Remove & Replace Curb Ramp With Two New Directional Ramps or Equivalent.

R204.3, R304.2.2, STD 1115

Total Cost: \$ 6160
