# Access Compliance Report Public Rights-of-Way (Curb Ramps)

Main Street: LORING\_DR Cross Street: HARRISBURG\_RD Location: SE

ADA ID: RPRK211216135940 Ramp Type: Type 1 - Perpendicular Diagonal Initial Pass/Fail: Pass Overall Compliance: No Severity Score: 12

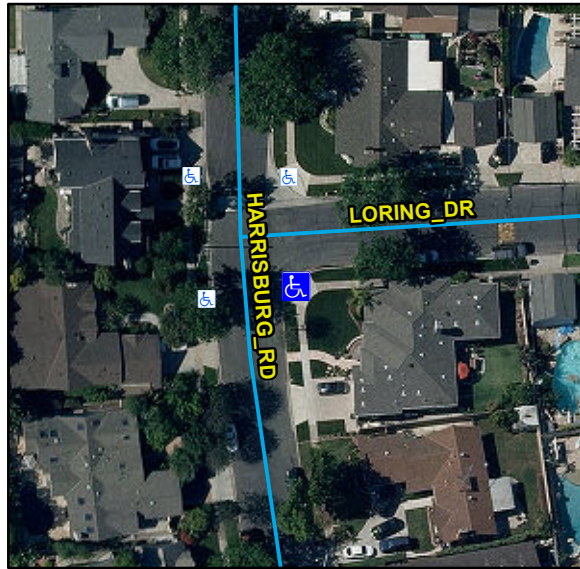
| Compliance | Description | Data | Compliance | Description | Data |
|---|---|---|---|---|---|
| No | Landing Run Slope (%) | 2.7 | N/A | Flare Traversable RT | No |
| Yes | Landing Cross Slope (%) | 0.7 | No | DWS Provided | No |

Remove & Replace Curb Ramp With Two New Directional Ramps or Equivalent.

R204.3, R304.2.2-Perp, R304.3.2-Para, R305, STD 1115
