# Access Compliance Report Public Rights-of-Way (Curb Ramps)

Main Street: MONTECITO\_RD Cross Street: LORING\_DR Location: SW

ADA ID: RPRK211216140249 Ramp Type: Type 1 - Perpendicular Diagonal Initial Pass/Fail: Pass Overall Compliance: No Severity Score: 0

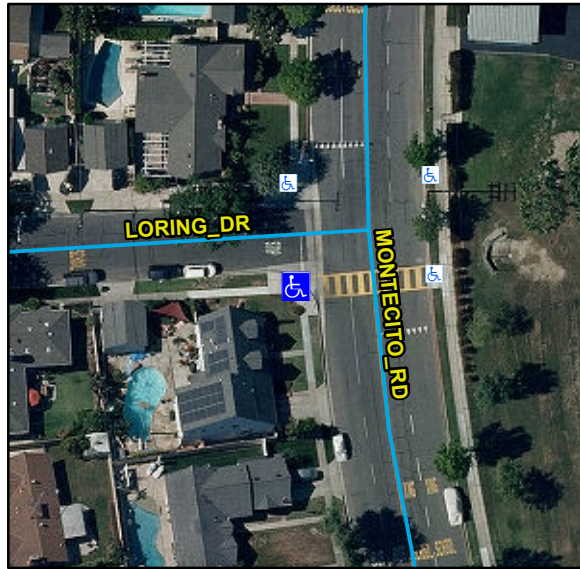
| Compliance | Description | Data | Compliance | Description | Data |
|---|---|---|---|---|---|
| Yes | Gutter Ponding | No | No | Curb Slope | 5.4 |

Possible Solutions:

Remove & Replace Curb Slope.

R304.2.2, STD 1115
