# Access Compliance Report Public Rights-of-Way (Curb Ramps)

Main Street: FOSTER\_RD Cross Street: KERTH\_DR Location: SE

ADA ID: RPRK211217111733 Ramp Type: Type 1 - Perpendicular Diagonal Initial Pass/Fail: Pass Overall Compliance: No Severity Score: 10

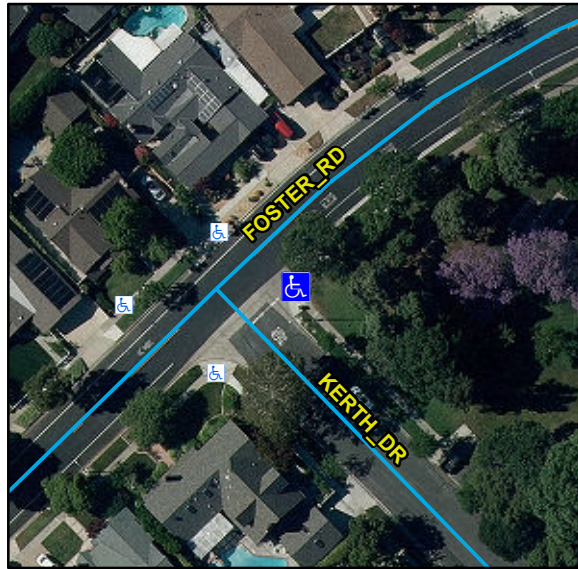
## Field Measurements/Component Compliance

| Compliance | Description | Data | Compliance | Description | Data |
|---|---|---|---|---|---|
| No | Landing Run Slope (%) | 3.2 | N/A | Flare Traversable RT | No |
| Yes | Landing Cross Slope (%) | 0.5 | No | DWS Provided | No |

**Remove & Replace Curb Ramp With Two New Directional Ramps or Equivalent.**
