# Access Compliance Report Public Rights-of-Way (Curb Ramps)

Main Street: KERTH\_DR Cross Street: FOSTER\_RD Location: SW

ADA ID: RPRK211217112202 Ramp Type: Type 1 - Perpendicular Diagonal Initial Pass/Fail: Fail Overall Compliance: No Severity Score: 2

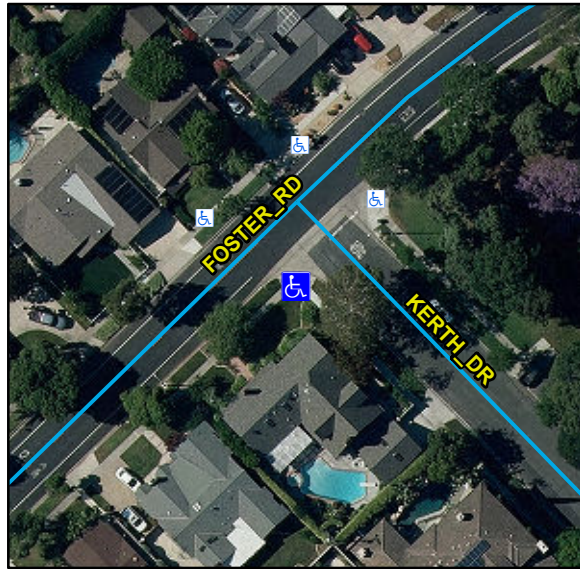
| Compliance | Description | Data | Compliance | Description | Data |
|---|---|---|---|---|---|
| No | Ramp Cross Slope (%) | 2.4 | N/A | Flare Traversable LT | N/A |
| No | Gutter Lip Height (in) | 1 | | Road Run Slope (%) | 0.6 |

**Remove & Replace Curb Ramp With Two New Directional Ramps or Equivalent. Grind Gutter Lip.**

**R204.3, R304.5.3, R302.7.2, STD 1115**
