# Access Compliance Report Public Rights-of-Way (Curb Ramps)

Main Street: DONOVAN\_RD Cross Street: KERTH\_DR Location: NW

ADA ID: RPRK211217112354 Ramp Type: Type 1 - Perpendicular Diagonal Initial Pass/Fail: Pass Overall Compliance: No Severity Score: 12

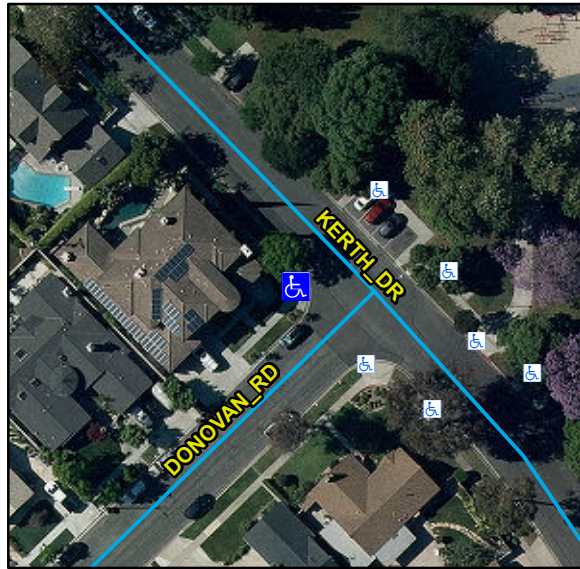
**R204.3, R305, STD 1115**

| Compliance | Description | Data | Compliance | Description | Data |
|---|---|---|---|---|---|
| Yes | Landing Cross Slope (%) | 0.5 | No | DWS Provided | No |

**Remove & Replace Curb Ramp With Two New Directional Ramps or Equivalent.**
