# Access Compliance Report Public Rights-of-Way (Curb Ramps)

Main Street: KERTH\_DR Cross Street: DONOVAN\_RD Location: S

ADA ID: RPRK211217112718 Ramp Type: Type 1 - Perpendicular Diagonal Initial Pass/Fail: Pass Overall Compliance: No Severity Score: 16

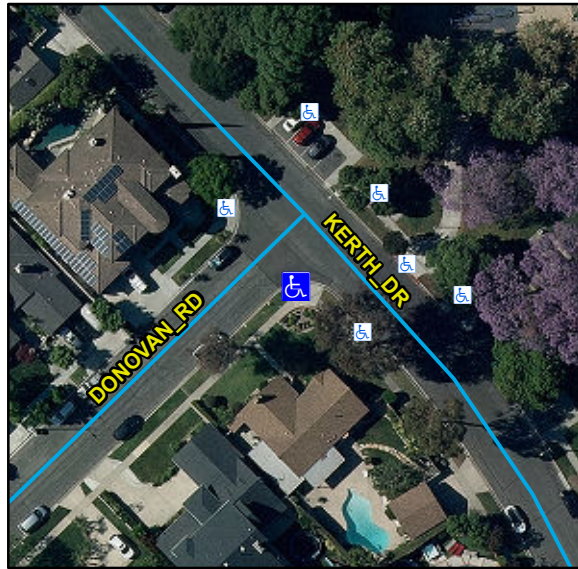
| Compliance | Description | Data | Compliance | Description | Data |
|---|---|---|---|---|---|
| No | Landing Run Slope (%) | 2.5 | N/A | Flare Traversable RT | No |
| Yes | Landing Cross Slope (%) | 1.1 | No | DWS Provided | No |
| No | Gutter Run Slope (%) | 5.6 | | Road Cross Slope (%) | 5.6 |

**Remove & Replace Curb Ramp With Two New Directional Ramps or Equivalent. Remove & Replace Gutter.**

**R304.2.2, R204.3, R304.2.1, R304.2.2-Perp, R304.3.2-Para, R305, R304.5.4, STD 1115**
