# Access Compliance Report Public Rights-of-Way (Curb Ramps)

| Main Street: KERTH_DR | | Cross Street: DONOVAN_RD | | Location: | E |
| ADA ID: RPRK211217113115 | Ramp Type:Type 1 - Perpendicular | Initial Pass/Fail: Pass | Overall Compliance: No | Severity Score: | 26 |

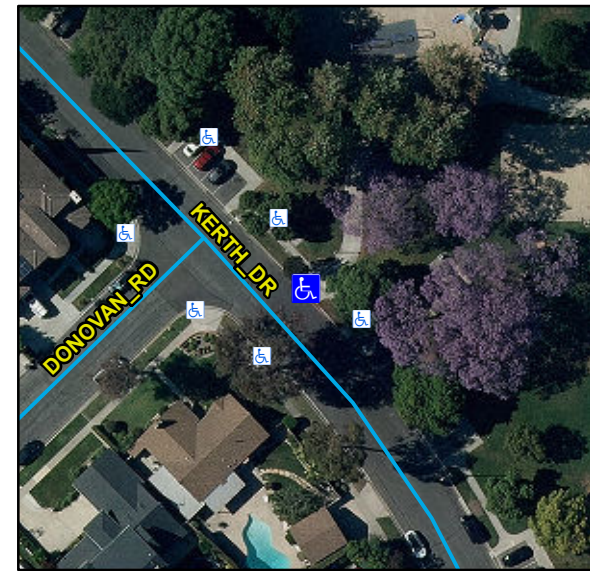
| Compliance | Description | Data | Compliance | Description | Data |
|---|---|---|---|---|---|
| Yes | Landing Cross Slope (%) | 0 | No | DWS Provided | No |
| No | Gutter Lip Height (in) | 1 | | Road Run Slope (%) | N/A |
| No | Gutter Run Slope (%) | 13.5 | | Road Cross Slope (%) | N/A |

Possible Solutions:

**Install Detectable Warning System. Remove & Replace Gutter.**

**R305, R302.7.2, R304.5.4, STD 1115**

Total Cost: \$ 852
