# Access Compliance Report Public Rights-of-Way (Curb Ramps)

Main Street: ORANGEWOOD\_AVE Cross Street: LOS\_ALAMITOS\_BLVD Location: SE

ADA ID: RPRK211217115305 Ramp Type: Type 1 - Perpendicular Diagonal Initial Pass/Fail: Pass Overall Compliance: No Severity Score: 5

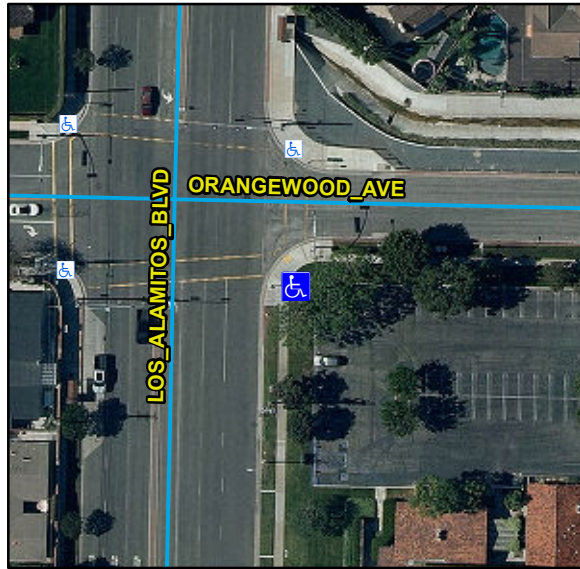
| Compliance | Description | Data | Compliance | Description | Data |
|---|---|---|---|---|---|
| Yes | Gutter Ponding | No | No | Curb Slope | 8.9 |
| No | Gutter Run Slope (%) | 7.2 | | Road Cross Slope (%) | 3.1 |

Remove & Replace Curb Slope. Remove & Replace Gutter.

R304.2.2, R304.5.4, STD 1115
