# Access Compliance Report Public Rights-of-Way (Curb Ramps)

Main Street: LOS\_ALAMITOS\_BLV D Cross Street: ORANGEWOOD\_AVE Location: NE

ADA ID: RPRK211217115925 Ramp Type: Type 1 - Perpendicular Diagonal Initial Pass/Fail: Pass Overall Compliance: No Severity Score: 6

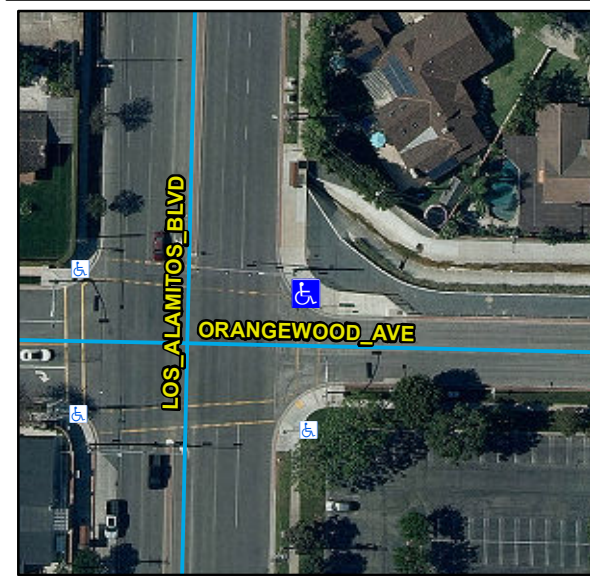
| Compliance | Description | Data | Compliance | Description | Data |
|---|---|---|---|---|---|
| Yes | Gutter Ponding | No | No | Curb Slope | 5.9 |
| No | Gutter Run Slope (%) | 12.3 | | Road Cross Slope (%) | 7.4 |

Possible Solutions:  
**Remove & Replace Curb Slope. Remove & Replace Gutter.**

OC Std/PROW:  
**R304.2.2, R304.5.4, STD 1115**

Total Cost: \$ 504
