# Access Compliance Report Public Rights-of-Way (Curb Ramps)

Main Street: ORANGEWOOD\_AVE Cross Street: LOS\_ALAMITOS\_BLV Location: NW

ADA ID: RPRK211217120529 Ramp Type: Type 1 - Perpendicular Diagonal Initial Pass/Fail: Pass Overall Compliance: No Severity Score: 5

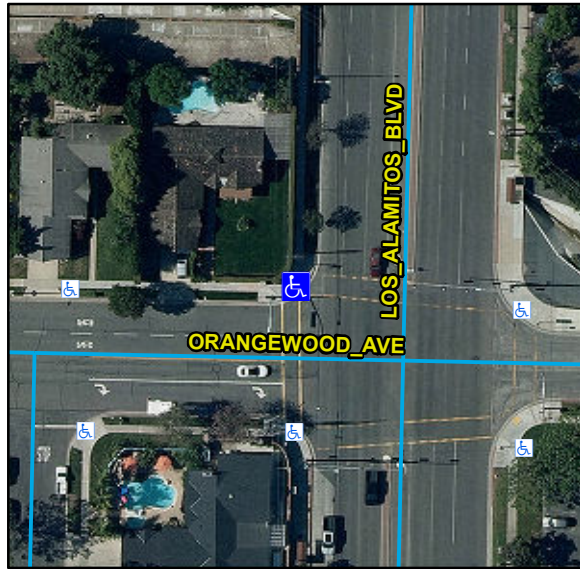
| Compliance | Description | Data | Compliance | Description | Data |
|---|---|---|---|---|---|
| Yes | Gutter Ponding | No | No | Curb Slope | 5.7 |
| No | Gutter Run Slope (%) | 12.2 | | Road Cross Slope (%) | 4.3 |

Remove & Replace Curb Slope. Remove & Replace Gutter.
