# Access Compliance Report Public Rights-of-Way (Curb Ramps)

Main Street: WEATHERBY\_RD Cross Street: ORANGEWOOD\_AVE Location: NE

ADA ID: RPRK211217121228 Ramp Type: Type 1 - Perpendicular Diagonal Initial Pass/Fail: Pass Overall Compliance: No Severity Score: 4

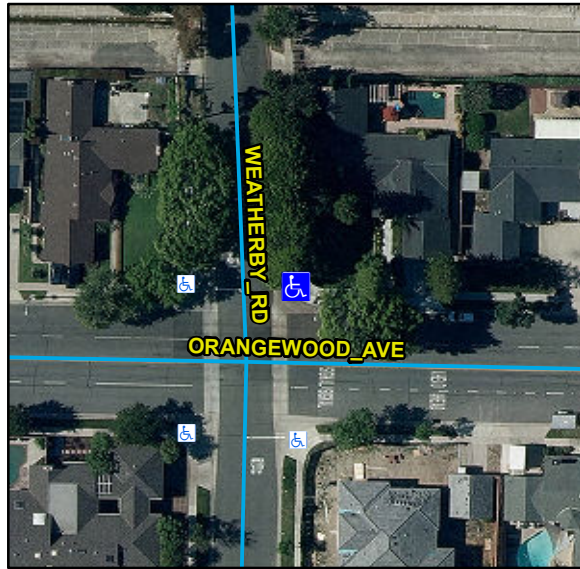
| Compliance | Description | Data | Compliance | Description | Data |
|---|---|---|---|---|---|
| N/A | Landing Length (in) | 40 | | | Sloped |
| N/A | Landing Movement Obstructed? | Yes | Yes | DWS Contrast | Yes |
| | Landing Movement Type | Curb | Yes | DWS Length (in) | 36 |

Possible Solutions:

Remove & Replace Landing.

R304.2.1, STD 1115

Total Cost: \$ 531
