# Access Compliance Report Public Rights-of-Way (Curb Ramps)

Main Street: ORANGEWOOD\_AVE Cross Street: WEATHERBY\_RD Location: NW

ADA ID: RPRK211217121601 Ramp Type: Type 1 - Perpendicular Diagonal Initial Pass/Fail: Pass Overall Compliance: No Severity Score: 4

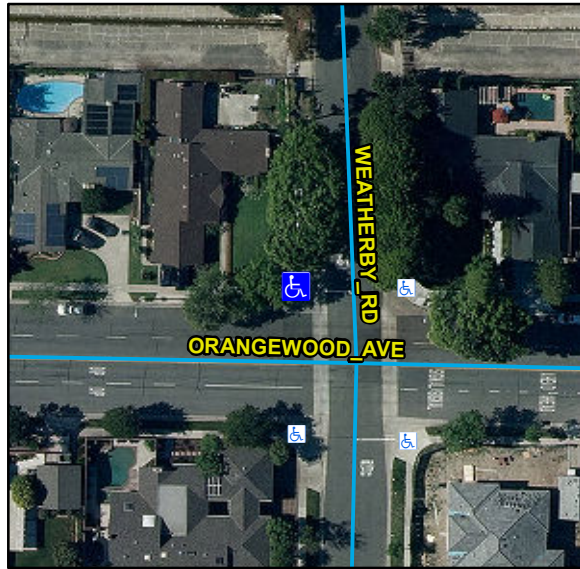
## Field Measurements/Component Compliance

| Compliance | Description | Data | Compliance | Description | Data |
|---|---|---|---|---|---|
| N/A | Landing Length (in) | 43 | | | Sloped |

Remove & Replace Landing.

R304.2.1, STD 1115
