# Access Compliance Report Public Rights-of-Way (Curb Ramps)

Main Street: WEATHERBY\_RD Cross Street: ORANGEWOOD\_AVE Location: SW

ADA ID: RPRK211217121940 Ramp Type: Type 1 - Perpendicular Diagonal Initial Pass/Fail: Pass Overall Compliance: No Severity Score: 4

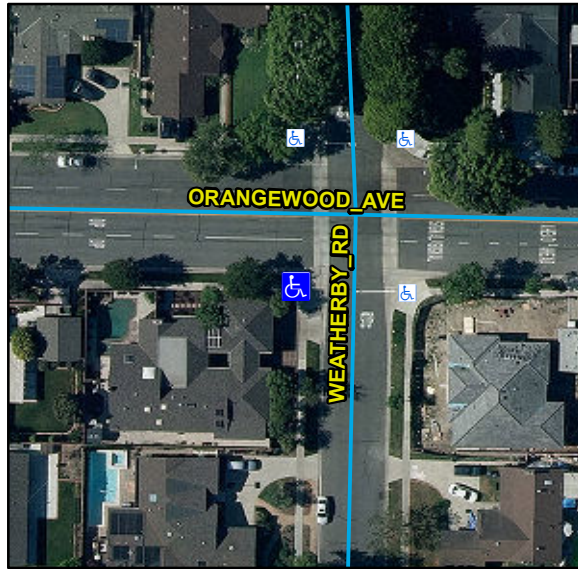
| Compliance | Description | Data | Compliance | Description | Data |
|---|---|---|---|---|---|
| N/A | Landing Present | Yes | N/A | Flare Type RT | |
| N/A | Landing Length (in) | 43 | | | Sloped |
| N/A | Landing Movement Obstructed? | Yes | Yes | DWS Contrast | Yes |
| | Landing Movement Type | Curb | Yes | DWS Length (in) | 36 |

Possible Solutions:

Remove & Replace Landing.

OC Std/PROW:

R304.2.1, STD 1115

Total Cost: \$ 531
