# Access Compliance Report Public Rights-of-Way (Curb Ramps)

Main Street: ORANGEWOOD\_AVE Cross Street: WEATHERBY\_RD Location: SE

ADA ID: RPRK211217122247 Ramp Type: Type 1 - Perpendicular Diagonal Initial Pass/Fail: Fail Overall Compliance: No Severity Score: 15

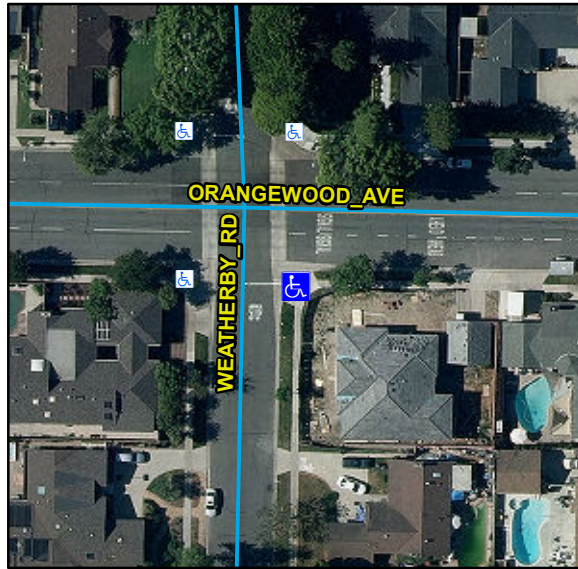
| Compliance | Description | Data | Compliance | Description | Data |
|---|---|---|---|---|---|
| No | Ramp Run Slope (%) | 8.7 | N/A | Flare Slope LT (%) | N/A |

**Remove & Replace Curb Ramp With Two New Directional Ramps or Equivalent.**
