# Access Compliance Report Public Rights-of-Way (Curb Ramps)

Main Street: WEATHERBY\_RD Cross Street: HUNTLEY\_DR Location: NE

ADA ID: RPRK211217123403 Ramp Type: Type 1 - Perpendicular Diagonal Initial Pass/Fail: Pass Overall Compliance: No Severity Score: 2

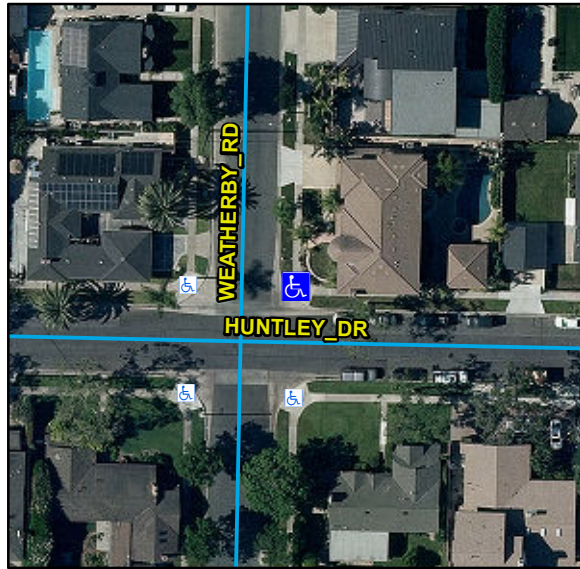
**Remove & Replace Landing. Gutter Ponding Observed.**

| Compliance | Description | Data | Compliance | Description | Data |
|---|---|---|---|---|---|
| No | Landing Run Slope (%) | 2.8 | N/A | Flare Traversable RT | No |
| No | Gutter Ponding | Yes | Yes | Curb Slope | 3.7 |

Possible Solutions:

**R304.2.2-Perp, R304.3.2-Para, R302.7, STD 1115**

Total Cost: \$ 783
