# Access Compliance Report Public Rights-of-Way (Curb Ramps)

Main Street: HUNTLEY\_DR Cross Street: WEATHERBY\_RD Location: SE

ADA ID: RPRK211217123657 Ramp Type: Type 1 - Perpendicular Diagonal Initial Pass/Fail: Pass Overall Compliance: No Severity Score: 2

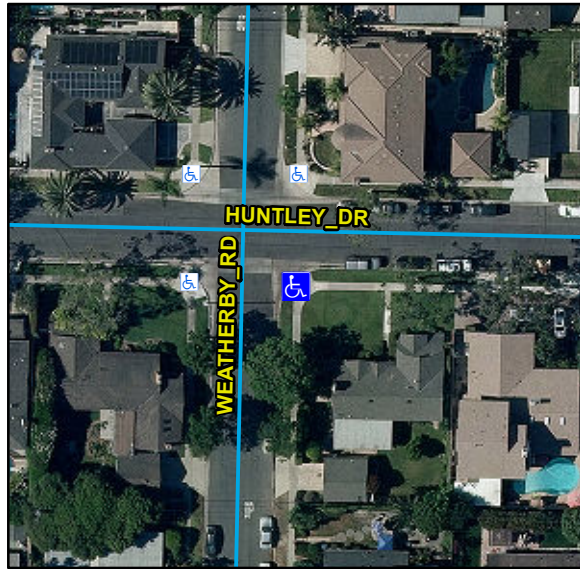
| Compliance | Description | Data | Compliance | Description | Data |
|---|---|---|---|---|---|
| No | Landing Run Slope (%) | 2.3 | N/A | Flare Traversable RT | No |
| No | Gutter Ponding | Yes | No | Curb Slope | 6.2 |

Remove & Replace Curb Ramp With Two New Directional Ramps or Equivalent.
