# Access Compliance Report Public Rights-of-Way (Curb Ramps)

Main Street: WEATHERBY\_RD Cross Street: ROSSMOOR\_WAY Location: N

ADA ID: RPRK211217124055 Ramp Type: Type 1 - Perpendicular Diagonal Initial Pass/Fail: Pass Overall Compliance: No Severity Score: 4

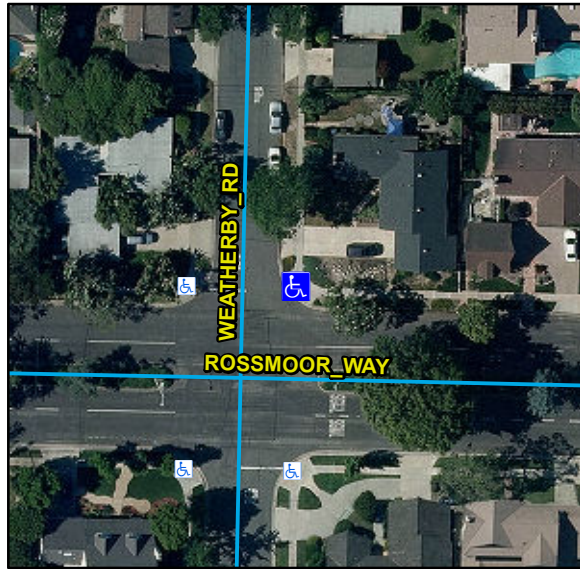
| Compliance | Description | Data | Compliance | Description | Data |
|---|---|---|---|---|---|
| No | Landing Cross Slope (%) | 2.5 | Yes | DWS Provided | Yes |
| N/A | Clear Space | Yes | No | DWS Offset Left (in) | 2.5 |
| N/A | Clear Space To Crosswalk (in) | 48 | No | DWS Offset Right (in) | N/A |
| No | Gutter Cross Slope (%) | 3.2 | | | |

Remove & Replace Curb Ramp With Two New Directional Ramps or Equivalent. Remove & Replace Gutter.
