# Access Compliance Report Public Rights-of-Way (Curb Ramps)

Main Street: ROSSMOOR\_WAY Cross Street: LOS\_ALAMITOS\_BLVD Location: SE

ADA ID: RPRK211217130127 Ramp Type: Type 1 - Perpendicular Diagonal Initial Pass/Fail: Pass Overall Compliance: No Severity Score: 6

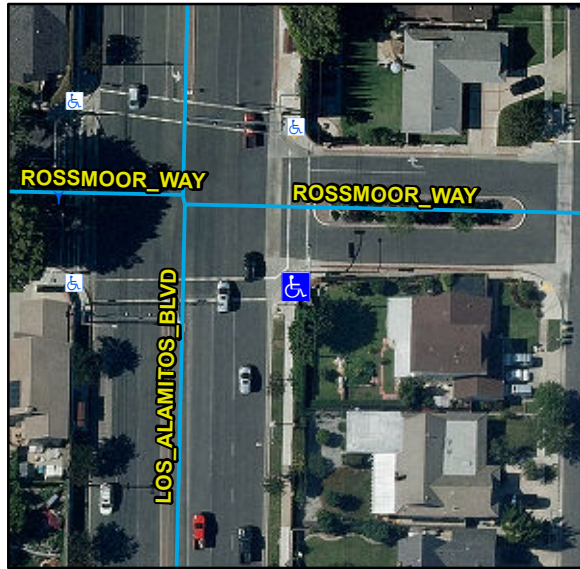
| Compliance | Description | Data | Compliance | Description | Data |
|---|---|---|---|---|---|
| N/A | Landing Length (in) | 36 | | | Sloped |

Possible Solutions:

Remove & Replace Landing.

R304.2.1, STD 1115
