# Access Compliance Report Public Rights-of-Way (Curb Ramps)

Main Street: LOS\_ALAMITOS\_BLV Cross Street: ROSSMOOR\_WAY Location: SW

ADA ID: RPRK211217130635 Ramp Type: Type 1 - Perpendicular Diagonal Initial Pass/Fail: Fail Overall Compliance: No Severity Score: 2

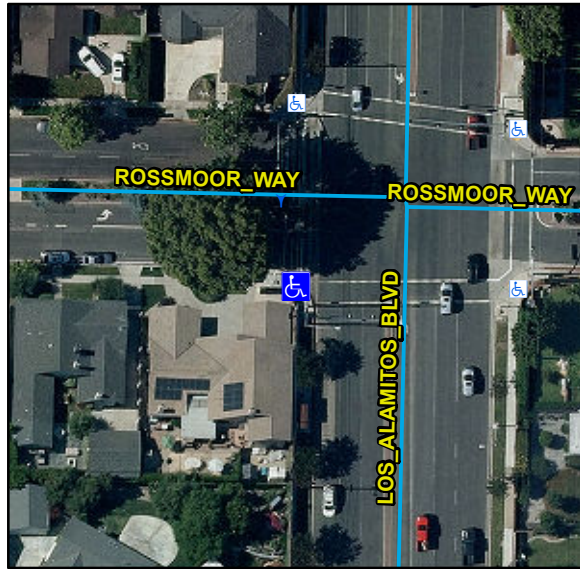
| Compliance | Description | Data | Compliance | Description | Data |
|---|---|---|---|---|---|
| No | Ramp Cross Slope (%) | 3.1 | N/A | Flare Traversable LT | N/A |

Remove & Replace Curb Ramp With Two New Directional Ramps or Equivalent.

R304.2.2, R304.5.3, STD 1115
