# Access Compliance Report Public Rights-of-Way (Curb Ramps)

Main Street: WEATHERBY\_RD Cross Street: ROSSMOOR\_WAY Location: SW

ADA ID: RPRK211217131551 Ramp Type: Type 1 - Perpendicular Diagonal Initial Pass/Fail: Fail Overall Compliance: No Severity Score: 15

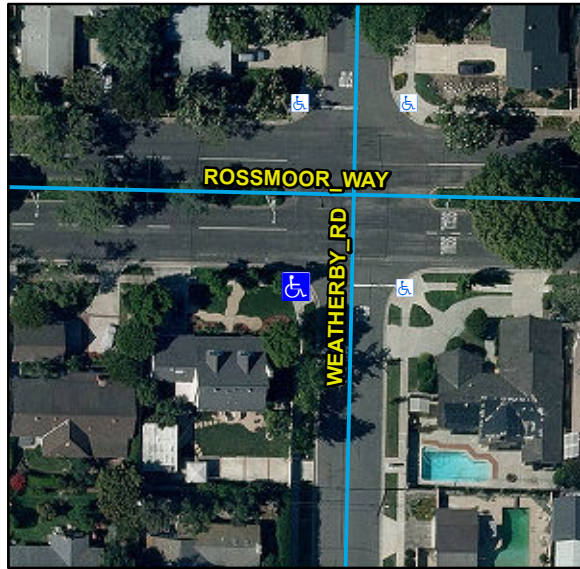
| Compliance | Description | Data | Compliance | Description | Data |
|---|---|---|---|---|---|
| No | Ramp Run Slope (%) | 9.1 | N/A | Flare Slope LT (%) | N/A |

Remove & Replace Curb Ramp With Two New Directional Ramps or Equivalent.

R204.3, R304.2.2, STD 1115
