# Access Compliance Report Public Rights-of-Way (Curb Ramps)

Main Street: CORTESE\_DR Cross Street: WEATHERBY\_RD Location: NW

ADA ID: RPRK211217132838 Ramp Type: Type 4 - Parallel Initial Pass/Fail: Fail Overall Compliance: No Severity Score: 2

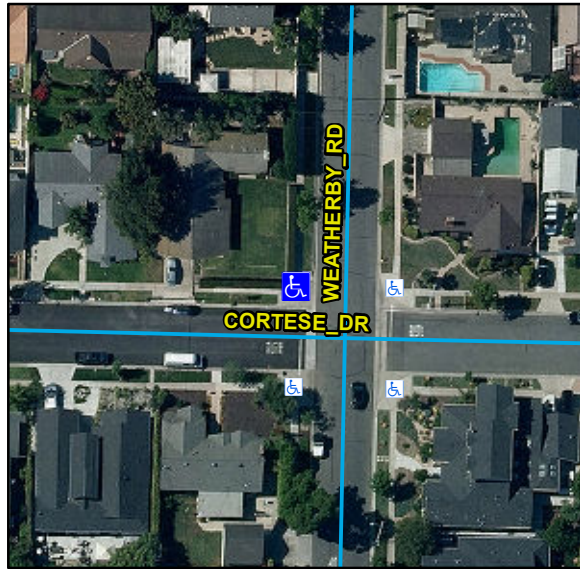
| Compliance | Description | Data | Compliance | Description | Data |
|---|---|---|---|---|---|
| No | Ramp Cross Slope LT (%) | 2.4 | Yes | Ramp Cross Slope RT (%) | 1.7 |

**Remove & Replace Curb Ramp With Two New Directional Ramps or Equivalent.**

**R304.5.3, STD 1115**
