# Access Compliance Report Public Rights-of-Way (Curb Ramps)

| Main Street: WEATHERBY_RD | | Cross Street: CORTESE_DR | | Location: | SW |
| ADA ID: RPRK211217133108 | Ramp Type: Type 4 - Parallel | Initial Pass/Fail: Fail | Overall Compliance: No | Severity Score: | 2 |

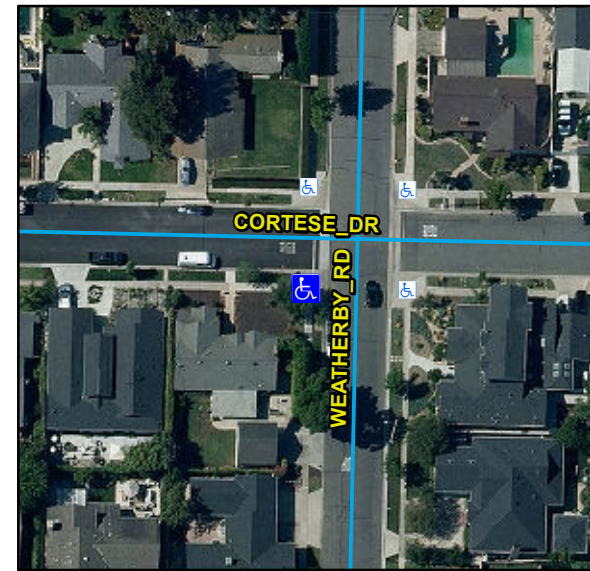
| Compliance | Description | Data | Compliance | Description | Data |
|---|---|---|---|---|---|
| No | Ramp Cross Slope LT (%) | 3.2 | Yes | Ramp Cross Slope RT (%) | 2 |

**Remove & Replace Curb Ramp With Two New Directional Ramps or Equivalent.**

**R304.5.3, STD 1115**
