# Access Compliance Report Public Rights-of-Way (Curb Ramps)

Main Street: CORTESE\_DR Cross Street: WEATHERBY\_RD Location: SE

ADA ID: RPRK211217133343 Ramp Type: Type 4 - Parallel Initial Pass/Fail: Pass Overall Compliance: No Severity Score: 9

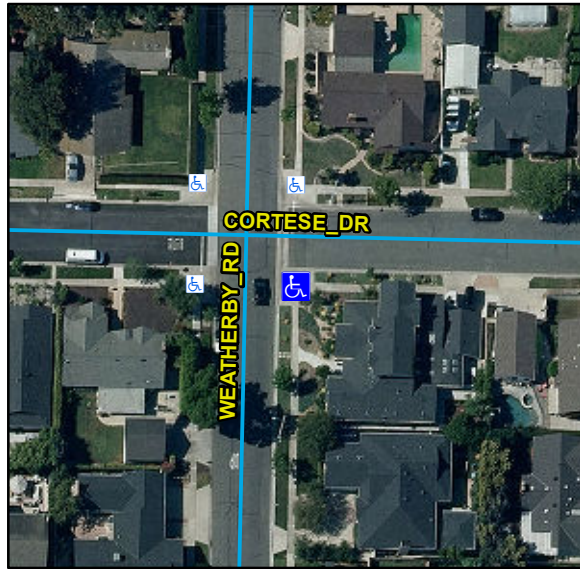
| Compliance | Description | Data | Compliance | Description | Data |
|---|---|---|---|---|---|
| Yes | Landing Run Slope (%) | 1.5 | No | DWS Full Width | No |

**Remove & Replace Curb Ramp With Two New Directional Ramps or Equivalent.**
