# Access Compliance Report Public Rights-of-Way (Curb Ramps)

| Main Street: ST_ALBANS_DR | | Cross Street: WEATHERBY_RD | | Location: | NW |
| ADA ID: RPRK211217133818 | Ramp Type: Type 4 - Parallel | Initial Pass/Fail: Fail | Overall Compliance: No | Severity Score: | 2 |

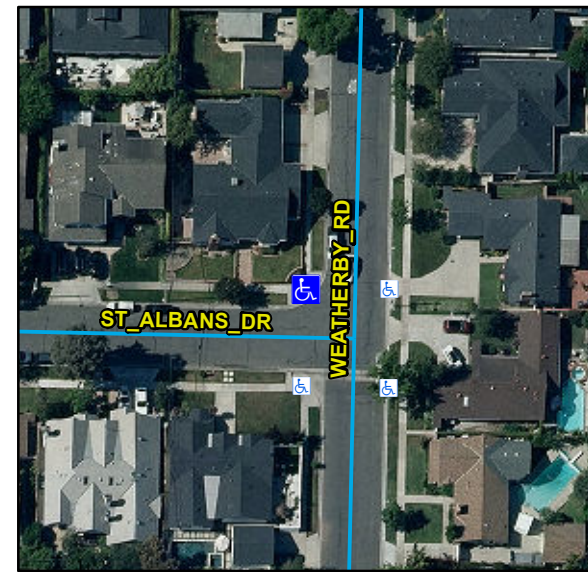
| Compliance | Description | Data | Compliance | Description | Data |
|---|---|---|---|---|---|
| Yes | Ramp Width LT (in) | 102 | Yes | Ramp Width RT (in) | 105 |
| Yes | Ramp Run Slope LT (%) | 7.4 | Yes | Ramp Run Slope RT (%) | 8.2 |
| No | Ramp Cross Slope LT (%) | 2.4 | No | Ramp Cross Slope RT (%) | 3.2 |

**Remove & Replace Curb Ramp With Two New Directional Ramps or Equivalent.**

**R304.5.3, STD 1115**

Total Cost: \$ 4000
