# Access Compliance Report Public Rights-of-Way (Curb Ramps)

Main Street: WEATHERBY\_RD Cross Street: ST\_ALBANS\_DR Location: SW

ADA ID: RPRK211217134125 Ramp Type: Type 4 - Parallel Initial Pass/Fail: Fail Overall Compliance: No Severity Score: 2

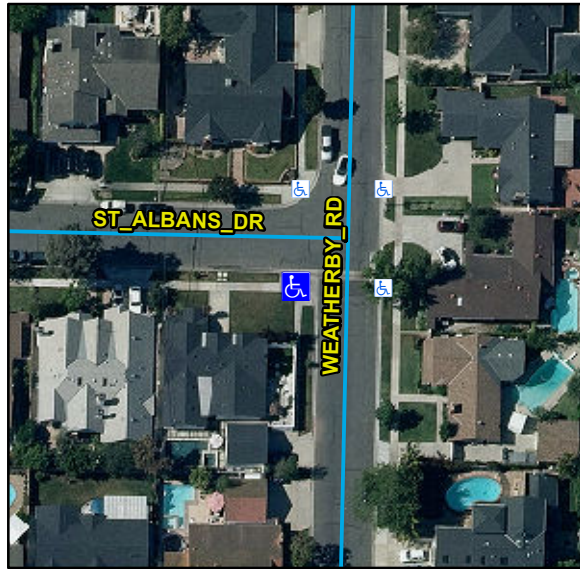
| Compliance | Description | Data | Compliance | Description | Data |
|---|---|---|---|---|---|
| Yes | Ramp Cross Slope LT (%) | 1.3 | No | Ramp Cross Slope RT (%) | 2.5 |

Remove & Replace Curb Ramp With Two New Directional Ramps or Equivalent.

R304.5.3, STD 1115
