# Access Compliance Report Public Rights-of-Way (Curb Ramps)

Main Street: WEATHERBY\_RD Cross Street: OAK\_KNOLL\_DR Location: SW

ADA ID: RPRK211217134544 Ramp Type: Type 4 - Parallel Initial Pass/Fail: Fail Overall Compliance: No Severity Score: 16

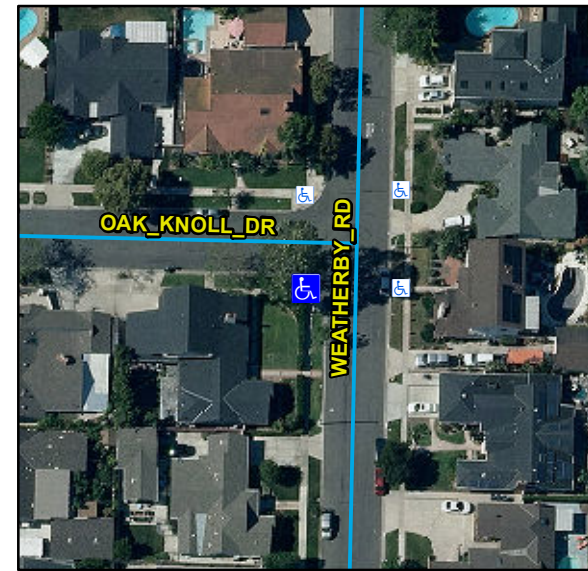
| Compliance | Description | Data | Compliance | Description | Data |
|---|---|---|---|---|---|
| No | Ramp Run Slope LT (%) | 9.2 | No | Ramp Run Slope RT (%) | 9.5 |
| No | Ramp Cross Slope LT (%) | 2.8 | No | Ramp Cross Slope RT (%) | 3.2 |

Possible Solutions:  
**Remove & Replace Curb Ramp With Two New Directional Ramps or Equivalent.**

R304.3.2, R304.5.3, STD 1115

Total Cost: \$ 4000
