# Access Compliance Report Public Rights-of-Way (Curb Ramps)

| Main Street: OAK_KNOLL_DR | | Cross Street: WEATHERBY_RD | | Location: | NW |
| ADA ID: RPRK211217134913 | Ramp Type: Type 4 - Parallel | Initial Pass/Fail: Pass | Overall Compliance: No | Severity Score: | 14 |

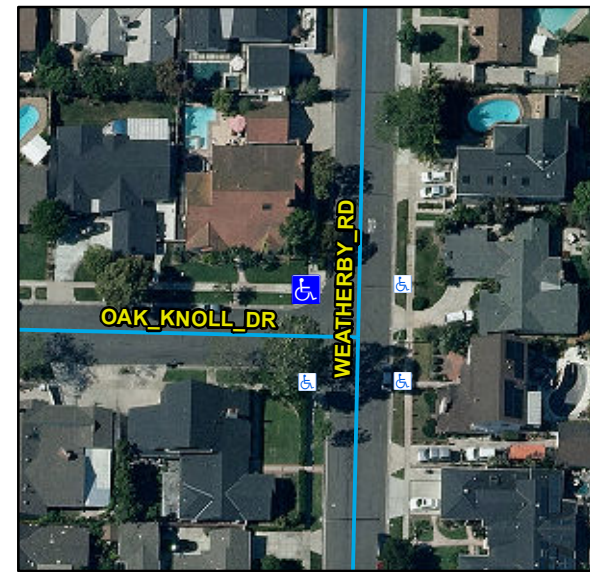
| Compliance | Description | Data | Compliance | Description | Data |
|---|---|---|---|---|---|
| Yes | Landing Run Slope (%) | 0.4 | No | DWS Full Width | No |
| No | Gutter Ponding | Yes | Yes | Curb Slope | 1.8 |
| No | Gutter Run Slope (%) | 5.4 | | Road Cross Slope (%) | 5.9 |

Remove & Replace Curb Ramp With Two New Directional Ramps or Equivalent. Remove & Replace Gutter.

R304.2.1, R305.1.4, R302.7, R304.5.4, STD 1115

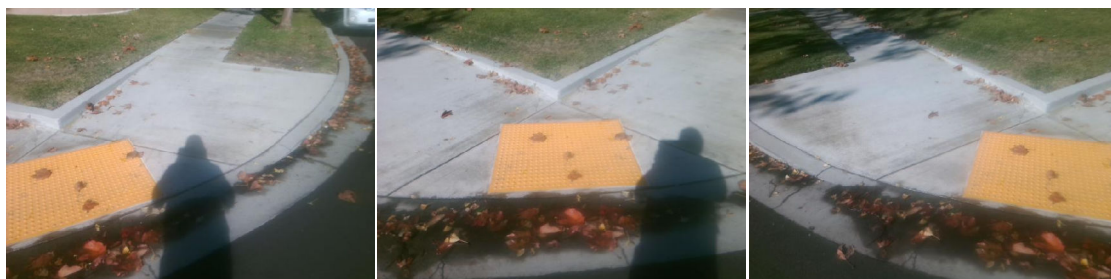
| Compliance | Description | Data | Compliance | Description | Data |
|---|---|---|---|---|---|
| N/A | Ramp Length LT (in) | 101 | N/A | Ramp Length RT (in) | 98 |
| Yes | Ramp Width LT (in) | 100 | Yes | Ramp Width RT (in) | 105 |
| Yes | Ramp Run Slope LT (%) | 5.2 | Yes | Ramp Run Slope RT (%) | 6.4 |
| Yes | Ramp Cross Slope LT (%) | 1.4 | Yes | Ramp Cross Slope RT (%) | 0.4 |
