# Access Compliance Report Public Rights-of-Way (Curb Ramps)

| Main Street: WALLINGSFORD_RD | | Cross Street: OAK_KNOLL_DR | | Location: | SW |
| ADA ID: RPRK211217135424 | Ramp Type: Type 4 - Parallel | Initial Pass/Fail: Fail | Overall Compliance: No | Severity Score: | 2 |

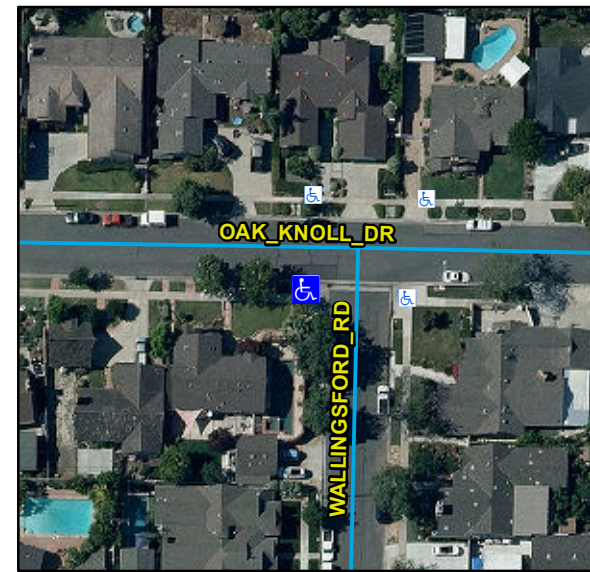
| Compliance | Description | Data | Compliance | Description | Data |
|---|---|---|---|---|---|
| No | Ramp Cross Slope LT (%) | 2.2 | Yes | Ramp Cross Slope RT (%) | 0.9 |

**Remove & Replace Curb Ramp With Two New Directional Ramps or Equivalent.**

**R304.5.3, STD 1115**
