# Access Compliance Report Public Rights-of-Way (Curb Ramps)

Main Street: MONTECITO\_RD Cross Street: OAK\_KNOLL\_DR Location: SW

ADA ID: RPRK211220112231 Ramp Type: Type 1 - Perpendicular Diagonal Initial Pass/Fail: Pass Overall Compliance: No Severity Score: 0

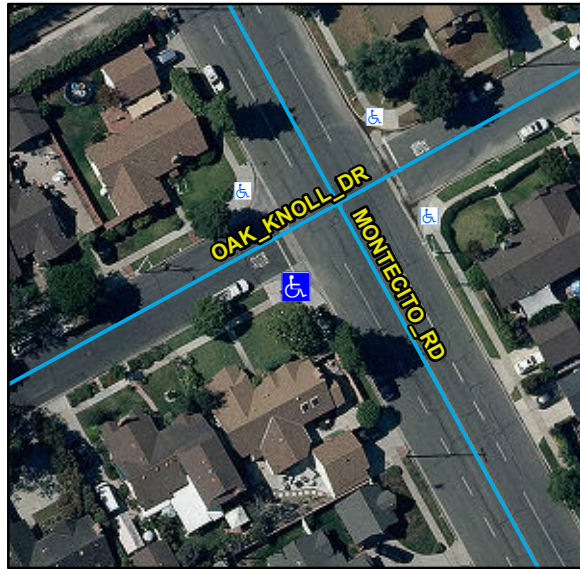
| Compliance | Description | Data | Compliance | Description | Data |
|---|---|---|---|---|---|
| Yes | Gutter Ponding | No | No | Curb Slope | 5.1 |

**Remove & Replace Curb Ramp With Two New Directional Ramps or Equivalent.**

R304.2.2, R304.2.1, STD 1115
