# Access Compliance Report Public Rights-of-Way (Curb Ramps)

Main Street: OAK\_KNOLL\_DR Cross Street: MONTECITO\_RD Location: SE

ADA ID: RPRK211220112537 Ramp Type: Type 4 - Parallel Initial Pass/Fail: Fail Overall Compliance: No Severity Score: 30

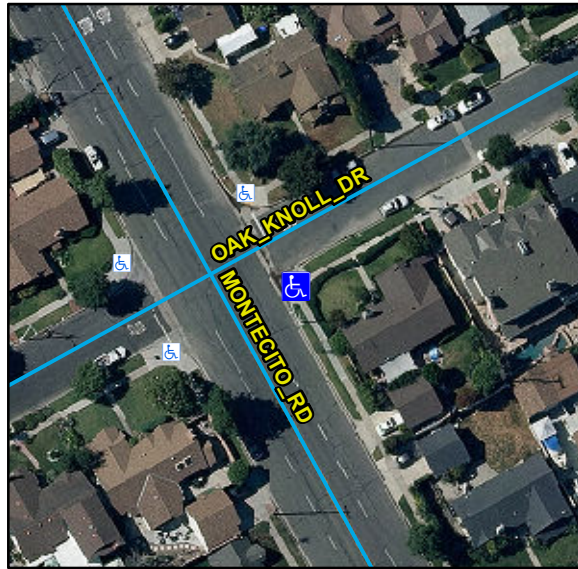
| Compliance | Description | Data | Compliance | Description | Data |
|---|---|---|---|---|---|
| Yes | Ramp Run Slope LT (%) | 3.9 | Yes | Ramp Run Slope RT (%) | 6.1 |
| No | Ramp Cross Slope LT (%) | 4.9 | No | Ramp Cross Slope RT (%) | 7.4 |

Remove & Replace Curb Ramp With Two New Directional Ramps or Equivalent.

R204.3, R304.5.3, STD 1115
