# Access Compliance Report Public Rights-of-Way (Curb Ramps)

| Main Street: MONTECITO_RD | | Cross Street: OAK_KNOLL_DR | | Location: | NE |
| ADA ID: RPRK211220112800 | Ramp Type: Type 4 - Parallel | Initial Pass/Fail: Fail | Overall Compliance: No | Severity Score: | 15 |

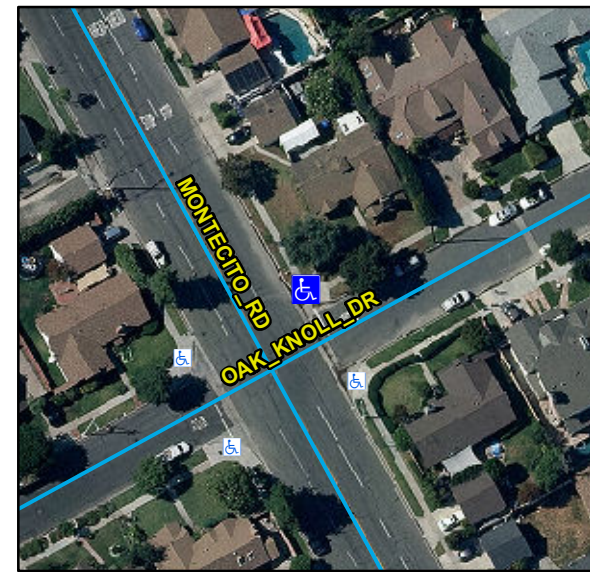
| Compliance | Description | Data | Compliance | Description | Data |
|---|---|---|---|---|---|
| No | Ramp Cross Slope LT (%) | 6.3 | No | Ramp Cross Slope RT (%) | 6.3 |

**Remove & Replace Curb Ramp With Two New Directional Ramps or Equivalent.**

**R204.3, R304.5.3, STD 1115**

Total Cost: \$ 4000

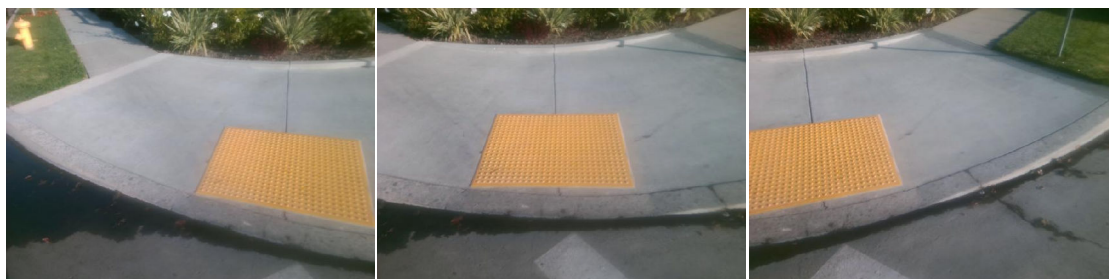
| Compliance | Description | Data | Compliance | Description | Data |
|---|---|---|---|---|---|
| N/A | Ramp Length LT (in) | 106 | N/A | Ramp Length RT (in) | 114 |
| Yes | Ramp Width LT (in) | 106 | Yes | Ramp Width RT (in) | 106 |
| Yes | Ramp Run Slope LT (%) | 6.6 | Yes | Ramp Run Slope RT (%) | 3.7 |
