# Access Compliance Report Public Rights-of-Way (Curb Ramps)

Main Street: MONTECITO\_RD Cross Street: ST\_ALBANS\_DR Location: NE

ADA ID: RPRK211220113430 Ramp Type: Type 1 - Perpendicular Diagonal Initial Pass/Fail: Pass Overall Compliance: No Severity Score: 0

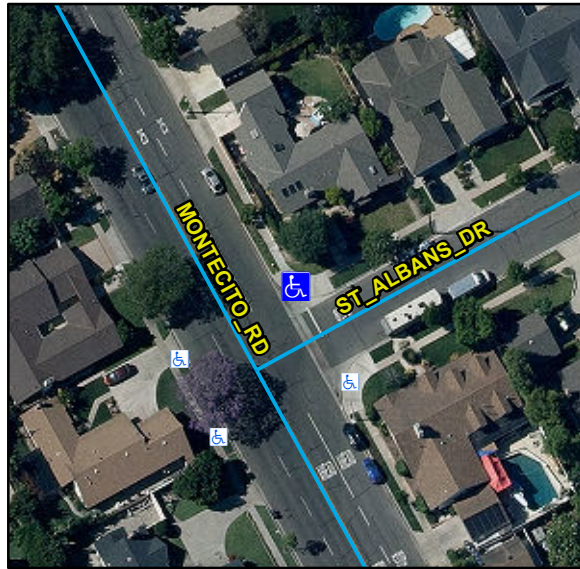
| Compliance | Description | Data | Compliance | Description | Data |
|---|---|---|---|---|---|
| N/A | Landing Length (in) | 58 | | | Sloped |
| N/A | Landing Movement Obstructed? | Yes | Yes | DWS Contrast | Yes |
| | Landing Movement Type | Curb | Yes | DWS Length (in) | 36 |

Remove & Replace Landing.

R304.2.1, STD 1115

Total Cost: \$ 531
