# Access Compliance Report Public Rights-of-Way (Curb Ramps)

Main Street: BRADBURY\_RD Cross Street: CHAUCER\_RD Location: S

ADA ID: RPRK211220114633 Ramp Type: Type 1 - Perpendicular Diagonal Initial Pass/Fail: Pass Overall Compliance: No Severity Score: 15

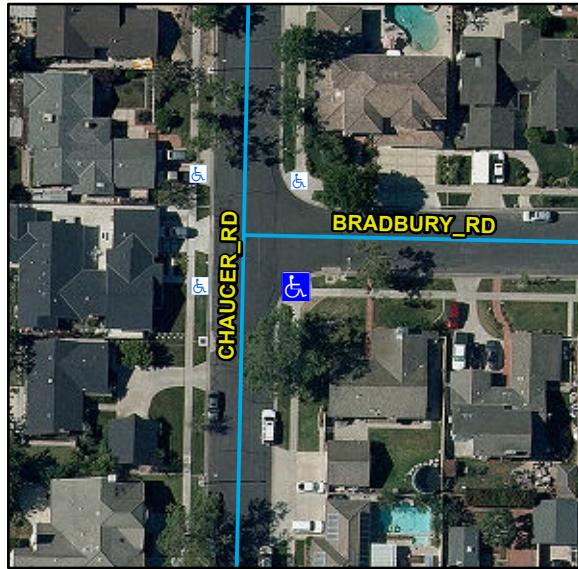
| Compliance | Description | Data | Compliance | Description | Data |
|---|---|---|---|---|---|
| Yes | Landing Cross Slope (%) | 0.5 | No | DWS Provided | No |
| No | Gutter Run Slope (%) | 6.5 | | Road Cross Slope (%) | 8.9 |

Remove & Replace Curb Ramp With Two New Directional Ramps or Equivalent. Remove & Replace Gutter.
