# Access Compliance Report Public Rights-of-Way (Curb Ramps)

Main Street: OAK GROVE RD Cross Street: CHAUCER RD Location: S

ADA ID: RPRK211220115905 Ramp Type: Type 1 - Perpendicular Diagonal Initial Pass/Fail: Pass Overall Compliance: No Severity Score: 16

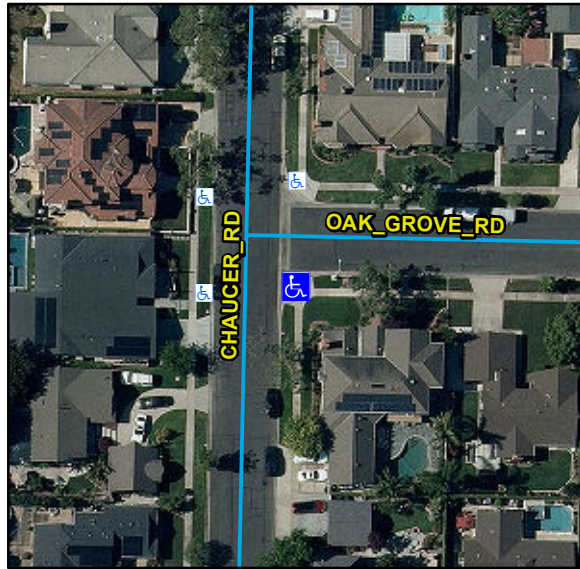
| Compliance | Description | Data | Compliance | Description | Data |
|---|---|---|---|---|---|
| No | Landing Cross Slope (%) | 2.3 | No | DWS Provided | No |

**Remove & Replace Curb Ramp With Two New Directional Ramps or Equivalent.**
