# Access Compliance Report Public Rights-of-Way (Curb Ramps)

Main Street: CHAUCER\_RD Cross Street: OAK GROVE\_RD Location: NE

ADA ID: RPRK211220120239 Ramp Type: Type 1 - Perpendicular Diagonal Initial Pass/Fail: Pass Overall Compliance: No Severity Score: 12

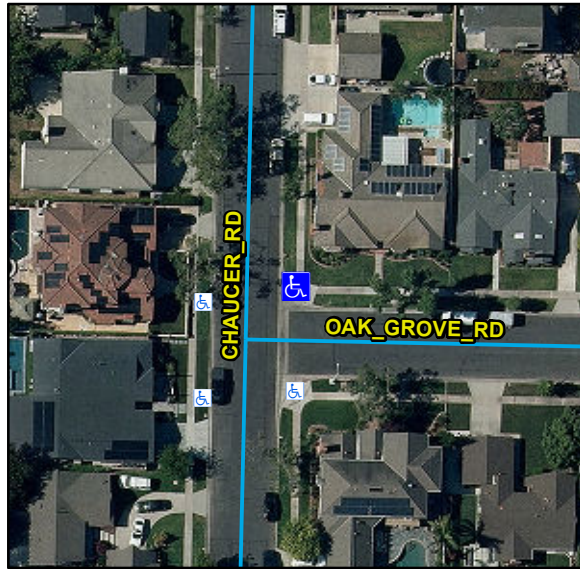
| Compliance | Description | Data | Compliance | Description | Data |
|---|---|---|---|---|---|
| Yes | Landing Cross Slope (%) | 0 | No | DWS Provided | No |

Remove & Replace Curb Ramp With Two New Directional Ramps or Equivalent.

R204.3, R305, STD 1115
