# Access Compliance Report Public Rights-of-Way (Curb Ramps)

Main Street: ST\_ALBANS\_DR Cross Street: SILVER\_FOX\_RD Location: SE

ADA ID: RPRK211220120903 Ramp Type: Type 1 - Perpendicular Diagonal Initial Pass/Fail: Pass Overall Compliance: No Severity Score: 14

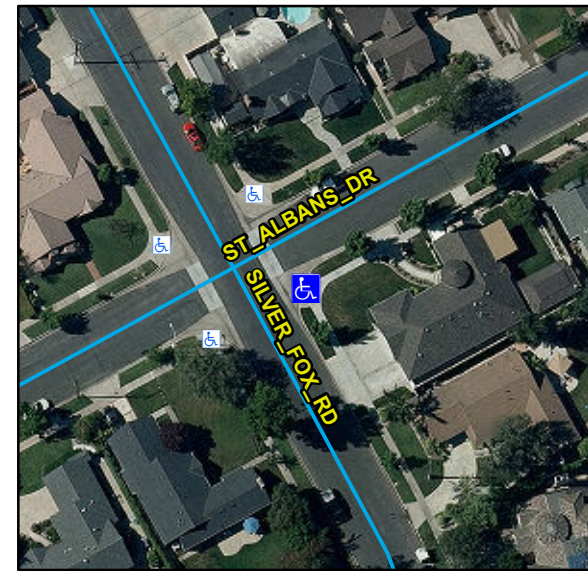
| Compliance | Description | Data | Compliance | Description | Data |
|---|---|---|---|---|---|
| No | Landing Run Slope (%) | 3.1 | N/A | Flare Traversable RT | No |
| Yes | Landing Cross Slope (%) | 0.1 | No | DWS Provided | No |

Remove & Replace Curb Ramp With Two New Directional Ramps or Equivalent.
