# Access Compliance Report Public Rights-of-Way (Curb Ramps)

| Main Street: SILVER_FOX_RD | | Cross Street: ST_ALBANS_DR | | Location: | NE |
| ADA ID: RPRK211220121220 | Ramp Type:Type 1 - Perpendicular Diagonal Initial Pass/Fail: Fail | | Overall Compliance: No | Severity Score: | 16 |

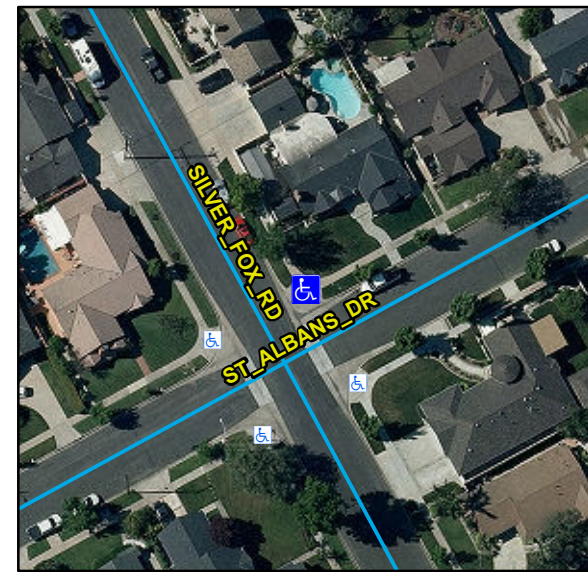
| Compliance | Description | Data | Compliance | Description | Data |
|---|---|---|---|---|---|
| No | Ramp Run Slope (%) | 8.6 | N/A | Flare Slope LT (%) | N/A |
| No | Gutter Lip Height (in) | 0.25 | | Road Run Slope (%) | 0.4 |

**Remove & Replace Curb Ramp With Two New Directional Ramps or Equivalent. Grind Gutter Lip.**

**R204.3, R304.2.2, R302.7.2, STD 1115**
