# Access Compliance Report

## Public Rights-of-Way

### (Curb Ramps)

Main Street: BOSTONIAN\_DR Cross Street: SILVER\_FOX\_RD Location: SE

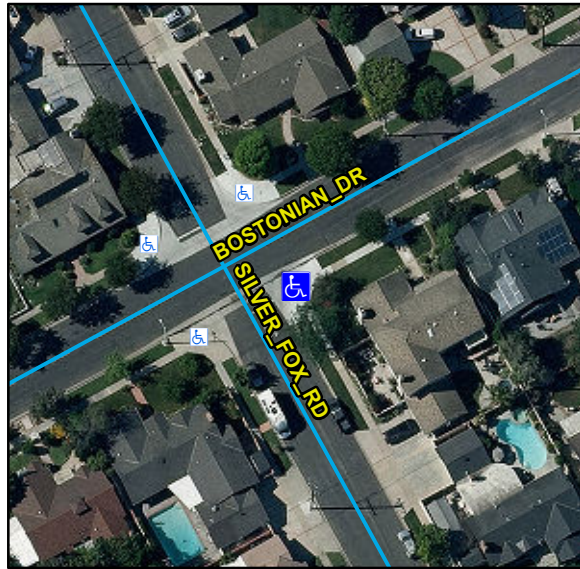
ADA ID: RPRK211220121417 Ramp Type: Type 1 - Perpendicular Diagonal Initial Pass/Fail: Pass Overall Compliance: Yes Severity Score: 0

#### Field Measurements/Component Compliance

Possible Solutions:

N/A
