# Access Compliance Report Public Rights-of-Way (Curb Ramps)

Main Street: SILVER\_FOX\_RD Cross Street: BOSTONIAN\_DR Location: SW

ADA ID: RPRK211220122414 Ramp Type: Type 1 - Perpendicular Diagonal Initial Pass/Fail: Pass Overall Compliance: No Severity Score: 0

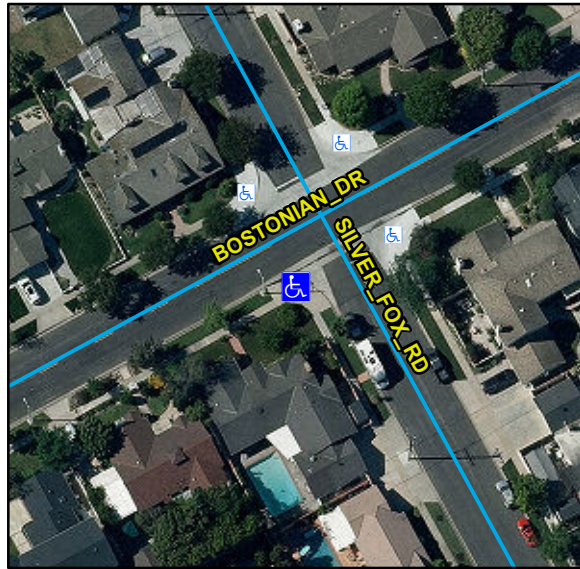
| Compliance | Description | Data | Compliance | Description | Data |
|---|---|---|---|---|---|
| N/A | Landing Movement Obstructed? | Yes | Yes | DWS Contrast | Yes |
| | Landing Movement Type | Curb | Yes | DWS Length (in) | 36 |

**Remove & Replace Landing.**

**R304.2.1, STD 1115**
