# Access Compliance Report Public Rights-of-Way (Curb Ramps)

Main Street: ST\_ALBANS\_DR Cross Street: SILVER\_FOX\_RD Location: NW

ADA ID: RPRK211220122722 Ramp Type: Type 1 - Perpendicular Diagonal Initial Pass/Fail: Pass Overall Compliance: No Severity Score: 10

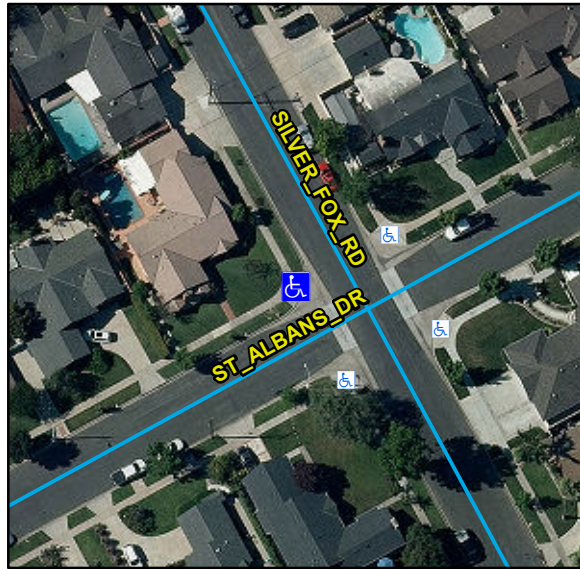
| Compliance | Description | Data | Compliance | Description | Data |
|---|---|---|---|---|---|
| No | Landing Run Slope (%) | 2.8 | N/A | Flare Traversable RT | No |
| Yes | Landing Cross Slope (%) | 0.4 | No | DWS Provided | No |

Remove & Replace Curb Ramp With Two New Directional Ramps or Equivalent.
