# Access Compliance Report Public Rights-of-Way (Curb Ramps)

Main Street: SILVER\_FOX\_RD Cross Street: ST\_ALBANS\_DR Location: SW

ADA ID: RPRK211220123054 Ramp Type: Type 1 - Perpendicular Diagonal Initial Pass/Fail: Pass Overall Compliance: No Severity Score: 14

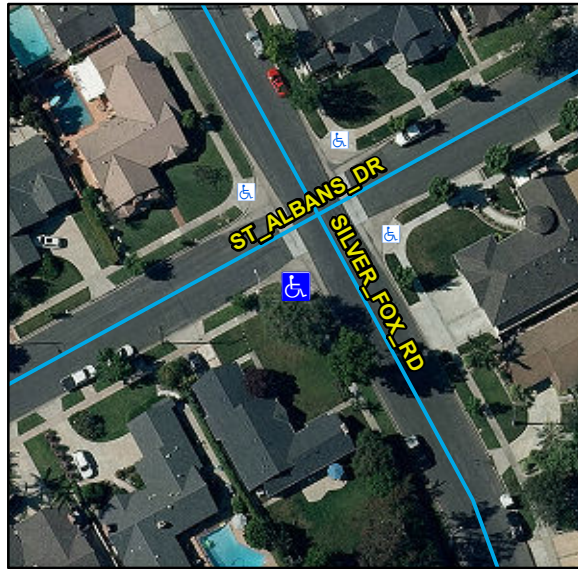
| Compliance | Description | Data | Compliance | Description | Data |
|---|---|---|---|---|---|
| Yes | Landing Cross Slope (%) | 0.2 | No | DWS Provided | No |
| Yes | Gutter Ponding | No | No | Curb Slope | 8.1 |

Remove & Replace Curb Ramp With Two New Directional Ramps or Equivalent.

R304.2.2, R204.3, R304.2.1, R305, STD 1115
