# Access Compliance Report Public Rights-of-Way (Curb Ramps)

| Main Street: OAK_KNOLL_DR | | Cross Street: SILVER_FOX_RD | | Location: | NW |
| ADA ID: RPRK211220123418 | Ramp Type:Type 1 - Perpendicular Diagonal Initial Pass/Fail: Fail | | Overall Compliance: No | Severity Score: | 16 |

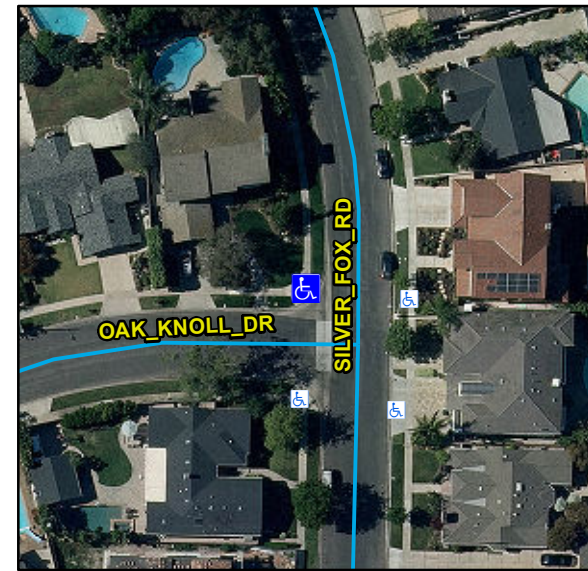
| Compliance | Description | Data | Compliance | Description | Data |
|---|---|---|---|---|---|
| No | Ramp Run Slope (%) | 8.4 | N/A | Flare Slope LT (%) | N/A |
| No | Gutter Lip Height (in) | 0.25 | | Road Run Slope (%) | 0.1 |

**Remove & Replace Curb Ramp With Two New Directional Ramps or Equivalent. Grind Gutter Lip.**

**R204.3, R304.2.2, R302.7.2, STD 1115**
