# Access Compliance Report Public Rights-of-Way (Curb Ramps)

Main Street: SILVER\_FOX\_RD Cross Street: OAK\_KNOLL\_DR Location: SW

ADA ID: RPRK211220123700 Ramp Type: Type 1 - Perpendicular Diagonal Initial Pass/Fail: Pass Overall Compliance: No Severity Score: 16

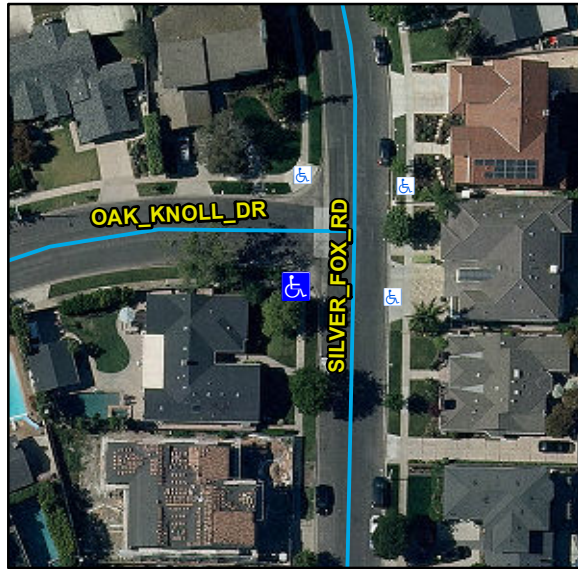
| Compliance | Description | Data | Compliance | Description | Data |
|---|---|---|---|---|---|
| No | Landing Run Slope (%) | 3.6 | N/A | Flare Traversable RT | No |
| Yes | Landing Cross Slope (%) | 0.7 | No | DWS Provided | No |
| No | Gutter Lip Height (in) | 0.25 | | Road Run Slope (%) | 0.2 |

Remove & Replace Curb Ramp With Two New Directional Ramps or Equivalent. Grind Gutter Lip.
