# Access Compliance Report Public Rights-of-Way (Curb Ramps)

| Main Street: BOSTONIAN_DR | | Cross Street: HARRISBURG_RD | | Location: | SE |
| ADA ID: RPRK211220124432 | Ramp Type: Type 4 - Parallel | Initial Pass/Fail: Fail | Overall Compliance: No | Severity Score: | 15 |

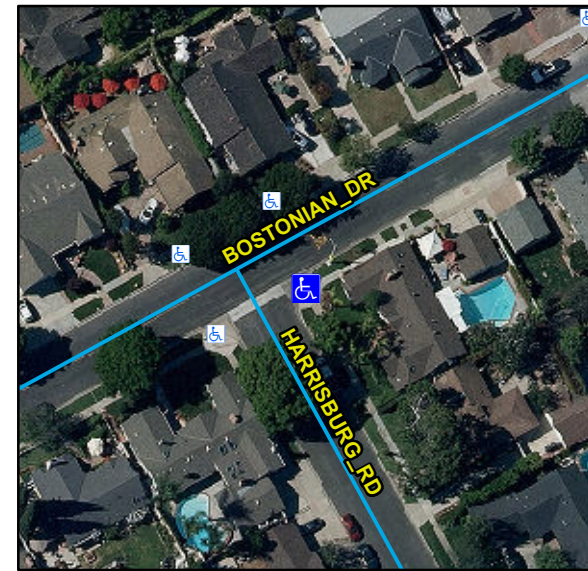
| Compliance | Description | Data | Compliance | Description | Data |
|---|---|---|---|---|---|
| No | Ramp Cross Slope LT (%) | 5.5 | No | Ramp Cross Slope RT (%) | 5.6 |

**Remove & Replace Curb Ramp With Two New Directional Ramps or Equivalent.**

**R304.5.3, STD 1115**
