# Access Compliance Report Public Rights-of-Way (Curb Ramps)

Main Street: HARRISBURG\_RD Cross Street: BOSTONIAN\_DR Location: SW

ADA ID: RPRK211220124710 Ramp Type: Type 1 - Perpendicular Diagonal Initial Pass/Fail: Pass Overall Compliance: No Severity Score: 16

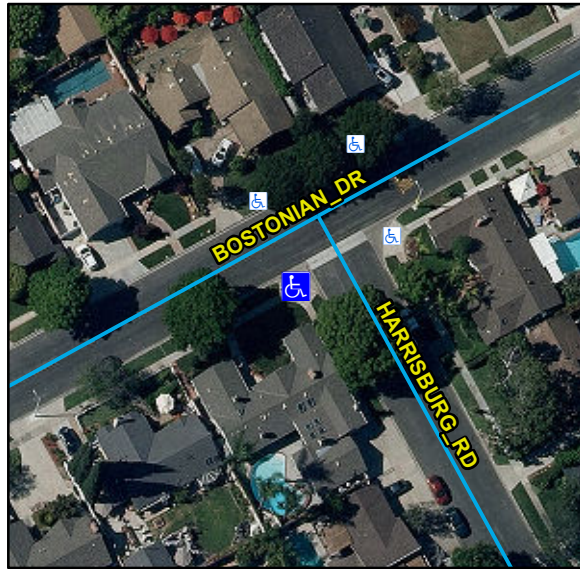
| Compliance | Description | Data | Compliance | Description | Data |
|---|---|---|---|---|---|
| No | Landing Run Slope (%) | 3.8 | N/A | Flare Traversable RT | No |
| Yes | Landing Cross Slope (%) | 0.6 | No | DWS Provided | No |
| Yes | Gutter Ponding | No | No | Curb Slope | 6.8 |

Remove & Replace Curb Ramp With Two New Directional Ramps or Equivalent.
