# Access Compliance Report Public Rights-of-Way (Curb Ramps)

Main Street: BOSTONIAN\_DR Cross Street: WEMBLEY\_RD Location: NW

ADA ID: RPRK211220125704 Ramp Type: Type 1 - Perpendicular Diagonal Initial Pass/Fail: Pass Overall Compliance: No Severity Score: 4

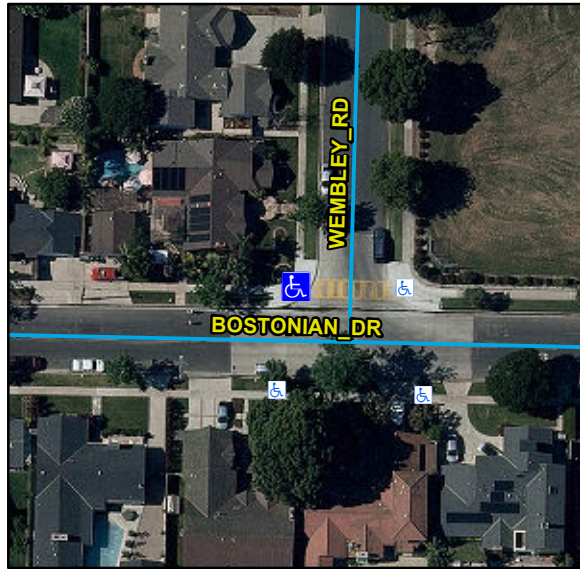
| Compliance | Description | Data | Compliance | Description | Data |
|---|---|---|---|---|---|
| N/A | Landing Movement Obstructed? | Yes | Yes | DWS Contrast | Yes |
| | Landing Movement Type | Curb | Yes | DWS Length (in) | 36 |

Remove & Replace Landing.

R304.2.1, STD 1115
