# Access Compliance Report Public Rights-of-Way (Curb Ramps)

Main Street: KENSINGTON\_RD Cross Street: BOSTONIAN\_DR Location: NE

ADA ID: RPRK211220130033 Ramp Type: Type 1 - Perpendicular Diagonal Initial Pass/Fail: Pass Overall Compliance: No Severity Score: 5

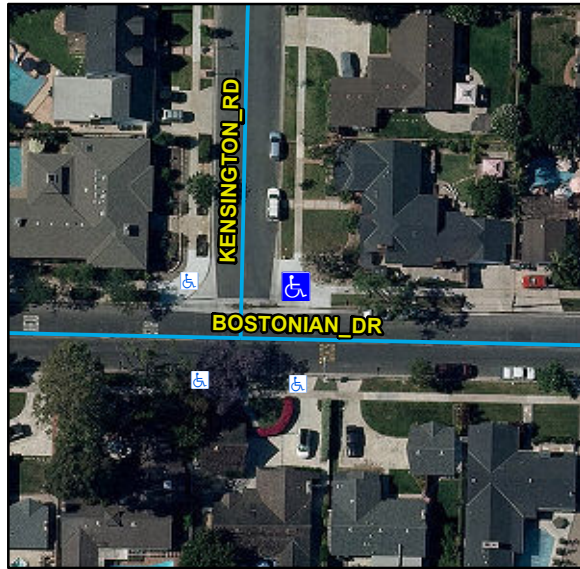
| Compliance | Description | Data | Compliance | Description | Data |
|---|---|---|---|---|---|
| No | Gutter Run Slope (%) | 5.3 | | Road Cross Slope (%) | 4.4 |

Remove & Replace Gutter.
