# Access Compliance Report Public Rights-of-Way (Curb Ramps)

Main Street: BOSTONIAN\_DR Cross Street: KENSINGTON\_RD Location: NW

ADA ID: RPRK211220130410 Ramp Type: Type 1 - Perpendicular Diagonal Initial Pass/Fail: Pass Overall Compliance: No Severity Score: 4

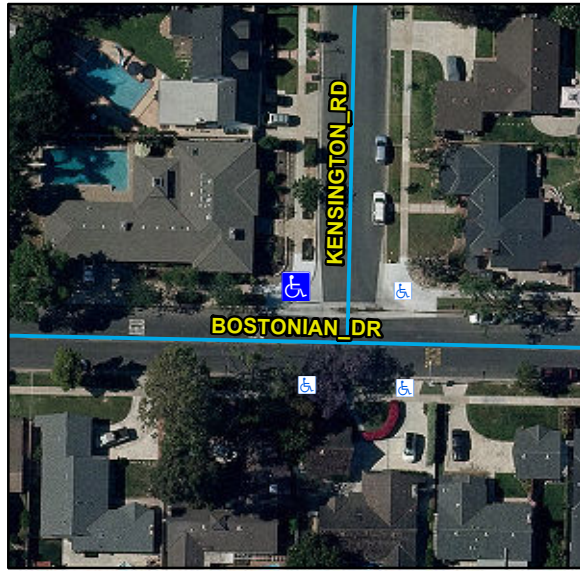
Remove & Replace Landing. Gutter Ponding Observed.

| Compliance | Description | Data | Compliance | Description | Data |
|---|---|---|---|---|---|
| No | Gutter Ponding | Yes | Yes | Curb Slope | 1.1 |

### Possible Solutions:

R304.2.1, R302.7, STD 1115
